Title no. 104-S30

Seismic Behavior of Shear-Critical Reinforced Concrete Frame: Experimental Investigation

by Kien Vinh Duong, Shamim A. Sheikh, and Frank J. Vecchio

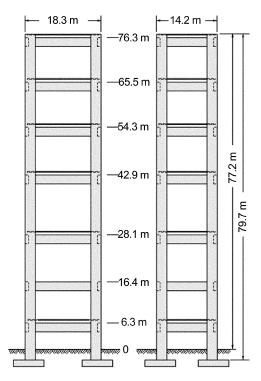
Elevation of Structure: 80 m (262 ft) high

All dimensions in m (1 m = 3.28 ft)

Fig. 1—Typical structural layout of cement plant tower.

Consider, for example, the cement plant preheater tower structure depicted in Fig. 1. It was constructed in 1999, nominally in accordance with ACI code specifications. In subsequent design reviews, a number of deficiencies were uncovered including: 1) the shear reinforcement amounts provided in some of the beams were inadequate to develop the beams' full flexural capacities; 2) the beams' longitudinal reinforcement did not fully penetrate the column joints as required by seismic detailing provisions, but rather was terminated short (refer to Fig. 2); and 3) in the lower story columns, the lateral confining reinforcement was inadequate with respect to its amount and spacing. Similar details have been used for a number of such structures recently constructed throughout the Americas. These and other deficiencies rendered the structure's expected performance under design seismic conditions highly questionable—likely inadequate and potentially catastrophic. The structure is currently being rehabilitated, including the strengthening of beams for shear using CFRP wrap.

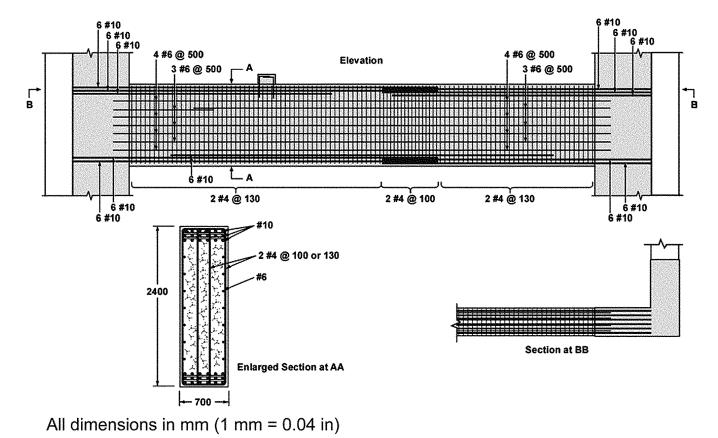
Fig. 2—Typical reinforcement details of cement plant tower.

A single-span, two-story, reinforced concrete frame with shear-critical beams was constructed and tested. The frame was designed to replicate, as much as possible, details in the preheater tower structure described previously, in aspects relating to expected shear response. Hence, the test frame attempted to conform to the tower's details in relation to beam span-to-depth ratio, shear reinforcement amounts, longitudinal reinforcement amounts, and material strengths. No attempt was made to replicate the details of the beam's

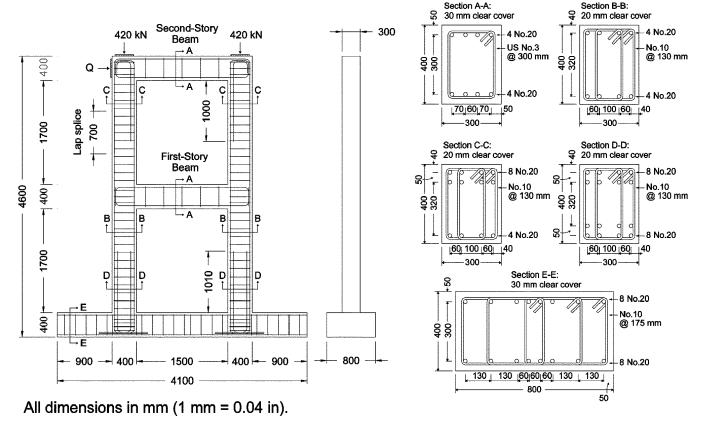
Fig. 3—Details of test frame.

The test frame stood approximately 4.6 m (15.1 ft) tall and 2.3 m (7.55 ft) wide (refer to Fig. 3 for details). The beams were nominally 300 mm (11.8 in.) wide by 400 mm (15.7 in.) deep. The columns also had dimensions of 300 x 400 mm (11.8 x 15.7 in.). To provide fixity at the bottom, a reinforced concrete base 800 mm (31.5 in.) wide, 400 mm (15.7 in.) thick, and 4100 mm (13.5 ft) long was built integrally with the body of the frame and post-tensioned to the strong floor prior to testing. The beam clear span was 1500 mm (4.9 ft) and the column clear story height was 1700 mm (5.6 ft). The concrete used was 43 MPa (6240 psi) with 10 mm (0.4 in.) maximum sized aggregates. Refer to Fig. 4 for the concrete stress-strain response.

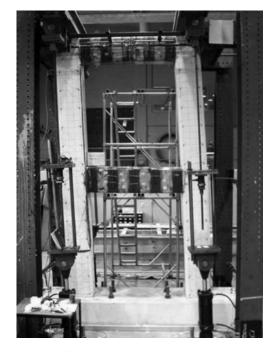
Fig. 15—Overall frame deformation at peak reverse cyclic load displacement (Phase B).

The overall load deformation responses of the test frame during Phase A and B of testing are summarized in Fig. 9 and 10, respectively. The lateral loads in the figures have been corrected for P-delta effects. Key load stages and load cycles are indicated. Key cracking patterns are shown in Fig. 11 through 13. The overall frame deformations after each phase of testing are presented in Fig. 14 and 15.
